Monitoring Data RecordProject Title: I-306 DB (I-85 in Durham) COE Action ID: 200020902Stream Name: South Ellerbee Creek (Sites 2 & 13) DWQ Number: 001040City, County and other Location Information: I-85 from W. of Broad St. to W. of Camden Ave. in Durham CountyDate Construction Completed: n/a Monitoring Quarter: (1) of 4Ecoregion: _____ 8 digit HUC unit 03020201

Section 1. PHOTO REFERENCE SITES*(Monitoring at all levels must complete this section)*

Section 3. CHANNEL STABILITY

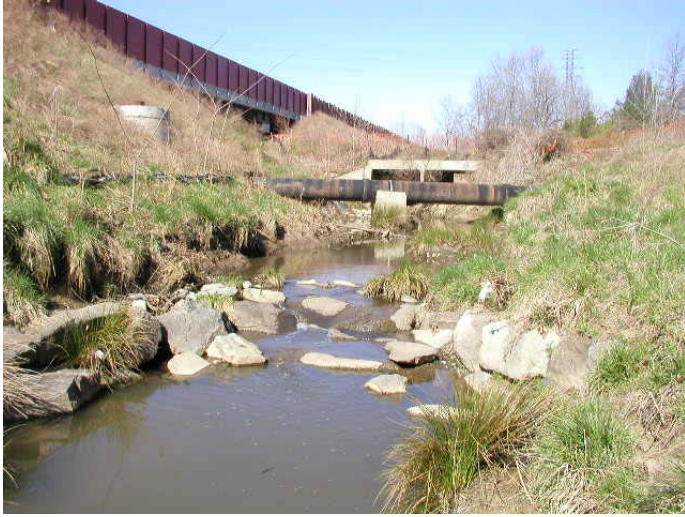
PP #10 Upstream (STA. 5+400-L- LT.)

Date Inspected	3/22/06 PP #10 Upstream Sta. 5+400-L- LT.	3/22/06 PP #12 Upstream Sta. 6+000-L- LT.	3/22/06 PP #15 Downstream Sta. 1+240 –CONAB- LT.
Structure Type	Cross Vane		
Is water piping through or around structure?			
Head cut or down cut present?			
Bank or scour erosion present?	Yes	Yes	
Other problems noted?	Repair failed cross vane and scour around sewer line.	Old culvert footing in stream will be altered so that it is not directing water flow into left bank.	Sheet pilings will be removed from stream relocation.
